# TECH TIPS

MAINTENANCE OF FIBERGLASS TO STEEL JOINT

NO. 129

**MODEL(S):**  
ALL TEREX UTILITIES INSULATED  
AERIAL DEVICES

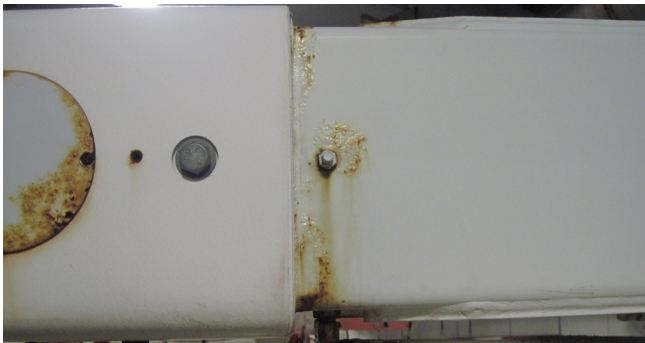
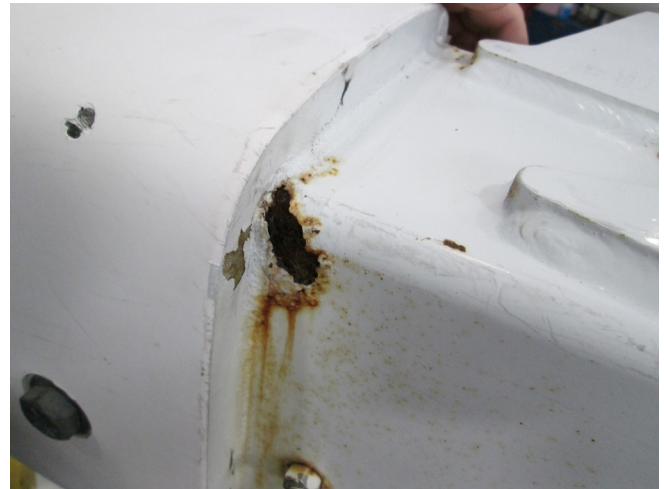
Maintenance of the caulking or sealant at the fiberglass to steel joint is very important. Failure to properly maintain the joint can lead to corrosion of the steel boom section or water and contaminants wicking into the fiberglass.

If corrosion progresses, the structural integrity of the boom is affected due to a reduction in the thickness of the material.

Water entering where the fiberglass is bonded to the steel can carry substances which can accelerate corrosion of the steel. In cold climates, it can freeze and cause the bond to fail.

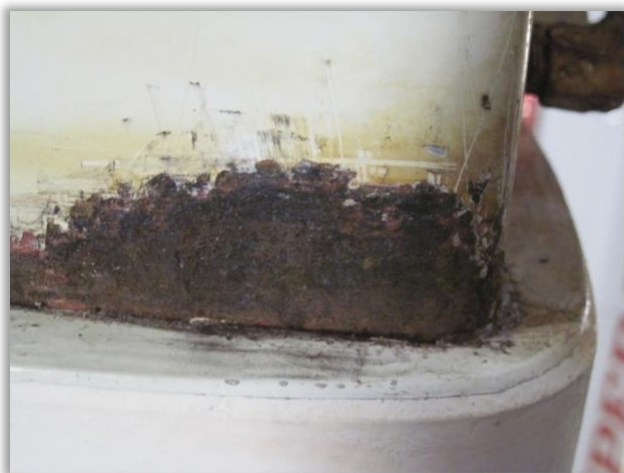
Below is an example of the information available in the unit specific maintenance manual.

The joint at the fiberglass and steel sections of the upper boom and the lower boom insert must be sealed with a bead of urethane or silicone caulk to prevent moisture entering the joint. Clean the area and apply a bead all around. Smooth so it bonds to both the steel and the fiberglass.

**!** Failure to maintain the caulk seal will trap moisture so the boom tubing can rust to the extent replacement will be necessary.

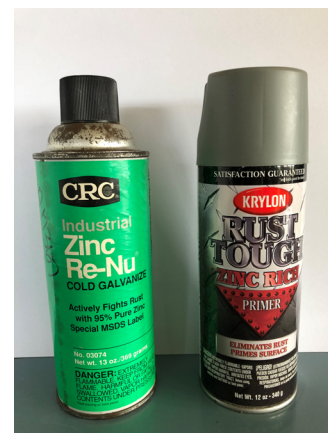
## STEP 5

Prime the bare metal with a zinc rich primer, following manufacturers application and safety guidelines. This should be readily available at your local auto parts or auto refinishing supply store. Finish painting by following the top coat manufacturer's application and safety guidelines.

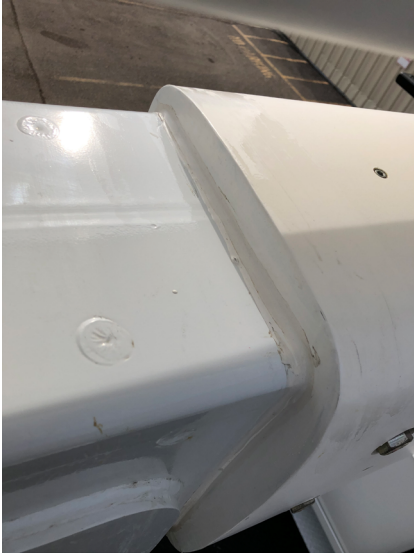
## STEP 6

Apply caulking to the fiberglass to steel boom joint, ensuring it adheres to both surfaces. The edge of the fiberglass boom section must be sealed if the original seal is damaged.

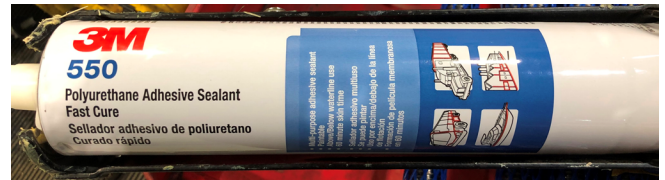
## STEP 7

The product used in manufacturing the booms is 3M Polyurethane Adhesive Sealant. It has been found to perform better than silicone products.

Part numbers:

3M: 62791

Grainger: 4YDH4
